Analyzing panel damage after a hailstorm

Hailstorm in the Netherlands

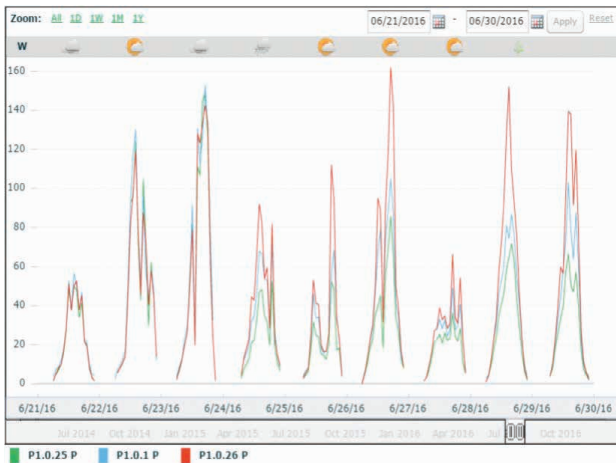
By analyzing and comparing the performance of three panels in a PV system, a noticeable decrease in production for two of the panels can be seen beginning on June 24, 2016, one day after the hailstorm.

The graph for Site 1 shows failing panels **P1.0.25 P**, **P1.0.1 P** compared to reference panel **P1.0.26 P**.

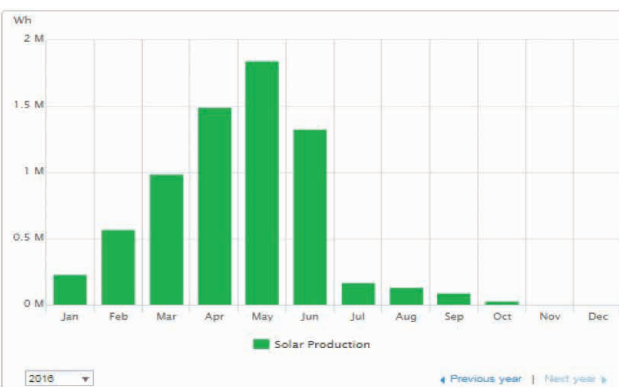
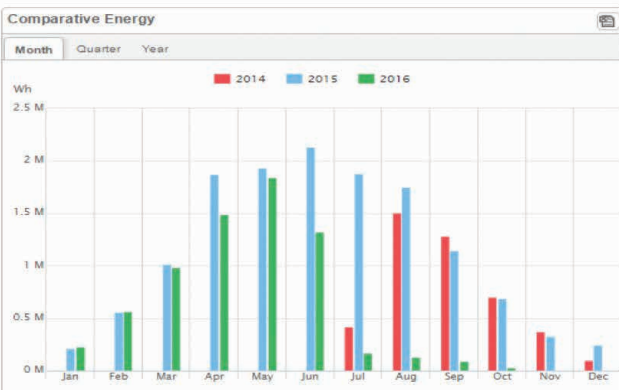
By analyzing the total system output of the affected site over a longer period of time, there is a marked dip in system energy production starting in June, which continues to decrease over the months that follow.

The graphs for Site 1 show the difference in monthly energy production.

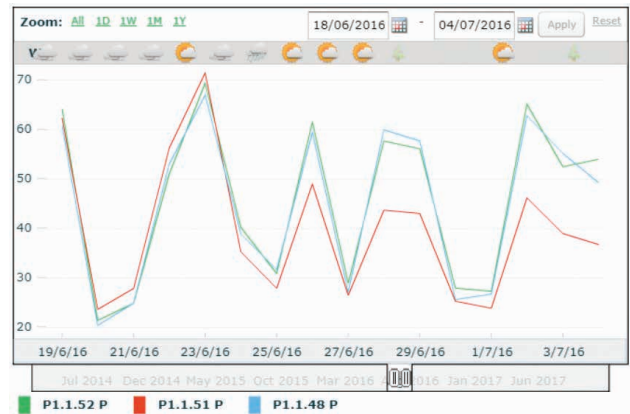
The graph below compares the power production of three panels over a seven-day period before and after the hailstorm. The chart shows normal production up to and including June 23, 2016. A marked decrease in panel 1.1.51 P's output (red curve) compared with the adjacent panels' output (green and blue curves) beginning on June 25, demonstrates the damaging effects caused by the hailstorm.

The graph for Site 2 shows failing panel **P1.1.51 P** compared to reference panels **P1.1.48 P** and **P1.1.52 P**.
